THE  
ECCLESIASTICAL  
ARCHITECTURE  
OF SCOTLAND

FROM THE EARLIEST CHRISTIAN TIMES TO THE  
SEVENTEENTH CENTURY

BY  
DAVID MACGIBBON AND THOMAS ROSS  
AUTHORS OF "THE CASTELLATED AND DOMESTIC ARCHITECTURE OF SCOTLAND"

VOLUME ONE

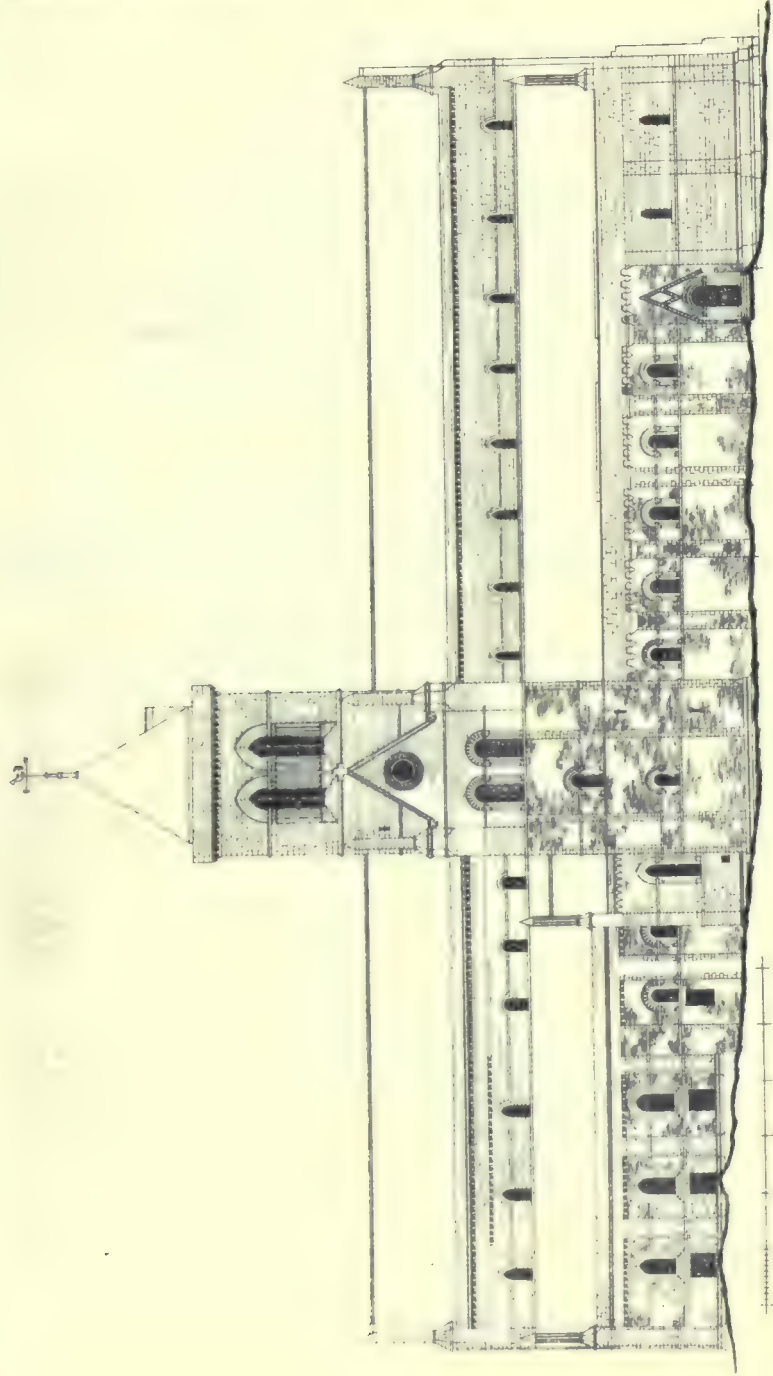
FIG. 228.—Kirkwall Cathedral. North Elevation.

When the exterior is examined, it is found to present at a glance a general history of the structure, and the changes which have taken place in it. The layers and masses of the different coloured stones which have been used in the edifice at different times tell their own tale. Fig. 228

shows the north elevation of the whole cathedral.\* The oldest work (which, however, comprises several periods) is constructed with dark slaty stone, having red freestone dressings. This masonry comprises the whole of the outer walls of the choir, the transept, and the greater part of the nave. It is evident, however, that this style of masonry includes not only much Norman work, with its round arches and flat buttresses, but also some later work, which has pointed windows and boldly-projected buttresses. The Norman work (Figs. 228 and 229) may be observed in the transept, and several bays of the nave and choir nearest the transept, while the pointed work is specially noticeable in the eastern half of the choir.

Turning to the nave, it will be observed (see Fig. 228) that the whole of the clerestory wall (except the two westmost bays) is built with whitish freestone, while the windows are of small size and are pointed. The clerestory of the nave thus corresponds with the raised part of that of the choir in the stone used, but differs from it in the windows, which are narrow. The parapet and corbel table of this part of the building, and indeed throughout nearly the whole structure, are similar to those of the choir, and in the later work have evidently been copied from the earlier ones. In the transept the alterations are plainly seen in the heightened portions of the north and south gables (see Figs. 229 and 230), which are carried out with red freestone ashlar, and in the details of the upper window of the north transept and the rose window of the south transept, which are all of a later character than the Norman work of the lower parts of the transept. In the south transept there may also be noticed a pointed doorway (Fig. 231) built with party-coloured stones, which has been inserted by cutting into the old Norman arcade of the interior. This is distinctly seen in the elevation of the interior (Fig. 232). Probably, when this was done, the older doorway which existed at the east end of the nave south aisle, in the usual position for access to the cloister, was built up, the intention of having a cloister being abandoned. Some traces of the impost of the arch of the original doorway, carved with Norman enrichments, may still be seen.

The two westmost bays of the nave (see Fig. 228) are built almost entirely from top to bottom with red freestone, having a slight admixture of white stone. This indicates a considerable alteration, and it will be found that these two bays were rebuilt at a late period, when a new west

aisle wall opposite the three bays, west from the crossing, would appear to have been built early (see Figs. 228 and 229). The buttresses are of the flat Norman form, the three eastmost windows are moulded in three orders, with a label enrichment like the choir aisle windows, while the two windows to the west of above, although round, have mouldings of a first

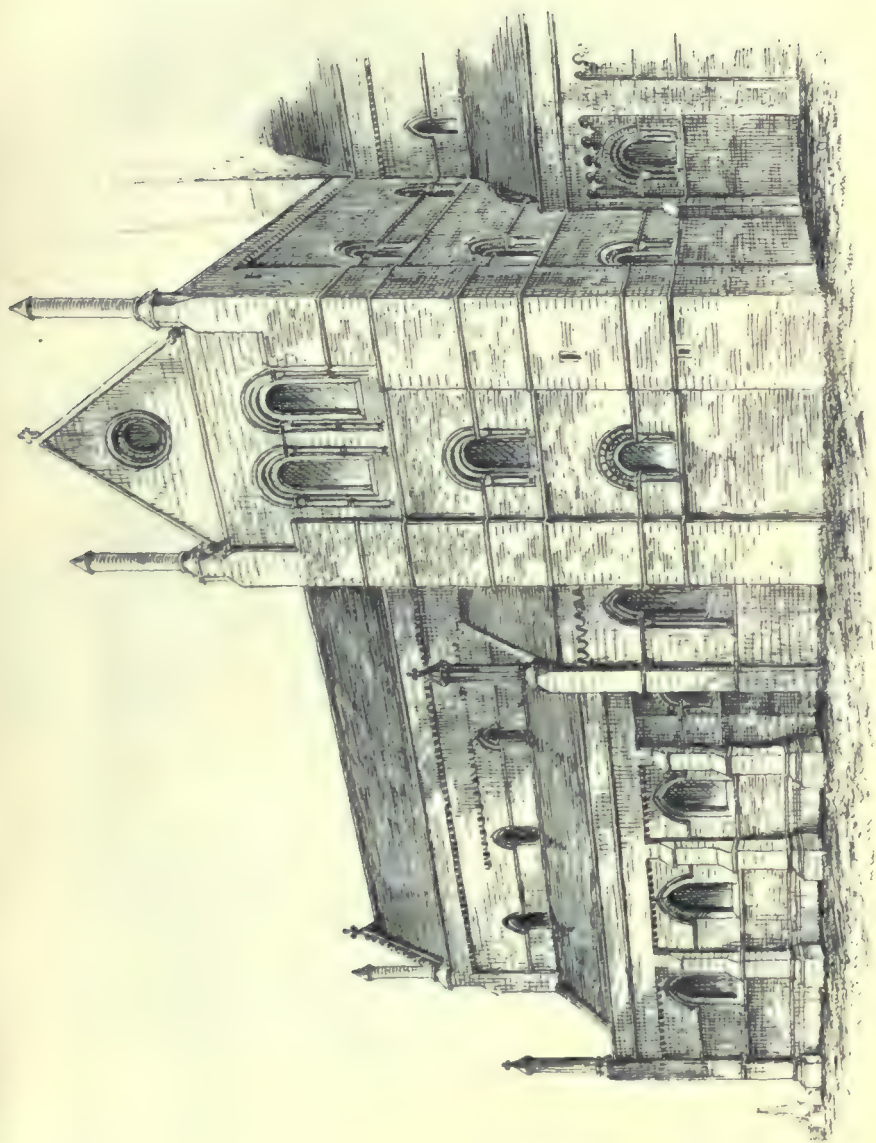
FIG. 229. — Kirkwall Cathedral. View of North Transept and Choir.

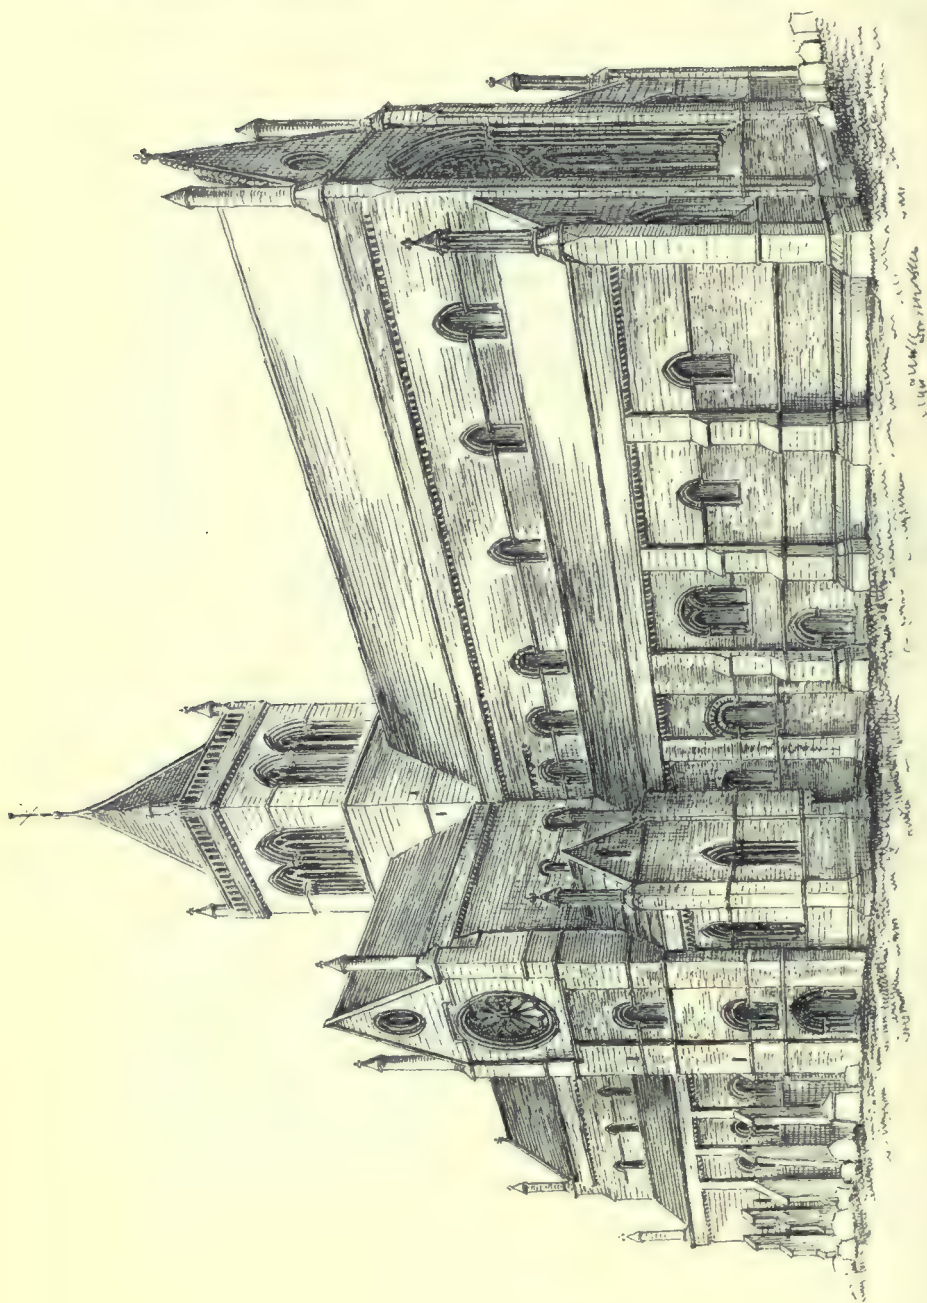
FIG. 230.—Kirkwall Cathedral. View from South-East.

The tower over the crossing (see Fig. 230) has been considerably operated upon in modern times. The old wooden spire was destroyed by lightning in 1671, and the tower consequently required repairs. The parapet and pinnacles are modern, as also the pointed and slated roof; but the lower part seems to be of considerable age (see Section, Fig. 227). The part within the roof of the church is apparently of transition date, and the upper part, with the large pointed windows, is probably of fifteenth century work.

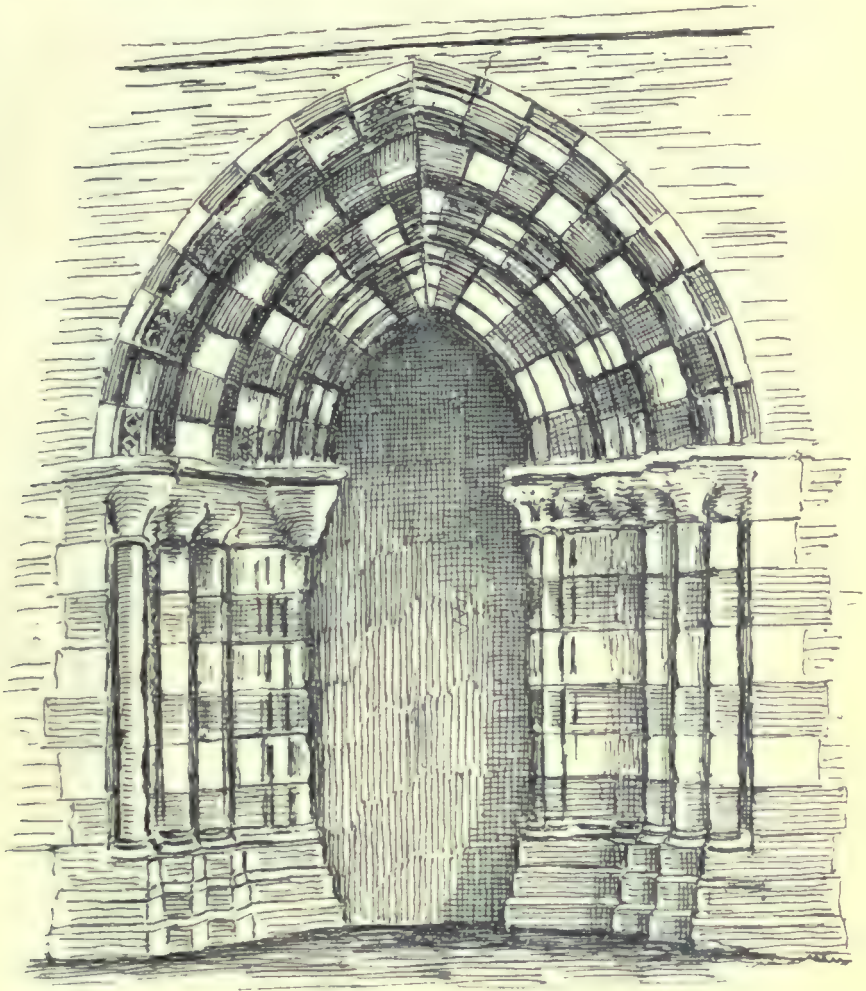
FIG. 231.—Kirkwall Cathedral. Doorway in South Transept.

The three western doorways (Fig. 241) and the pointed doorway in the south transept (see Fig. 231) must be assigned to a period rather later than the choir. The wall containing the three west doorways is built out

The three west doorways and that in the south transept are specially remarkable from their presenting probably the finest examples in Great Britain of the use of coloured stones in the construction. This is chiefly observable in the exterior, but is also carried out in the interior of these doorways (Fig. 242). The north doorway (Fig. 245) and central doorway (Fig. 244) of the west front have the colours arranged in concentric rings in the arches, red and yellow alternating. In the south doorway (Fig. 243) the same colours radiate and alternate, and in the doorway of the south transept the red and yellow stones are arranged chequerwise. (See Fig. 231.) Fig. 246 shows the plan of the central doorway.

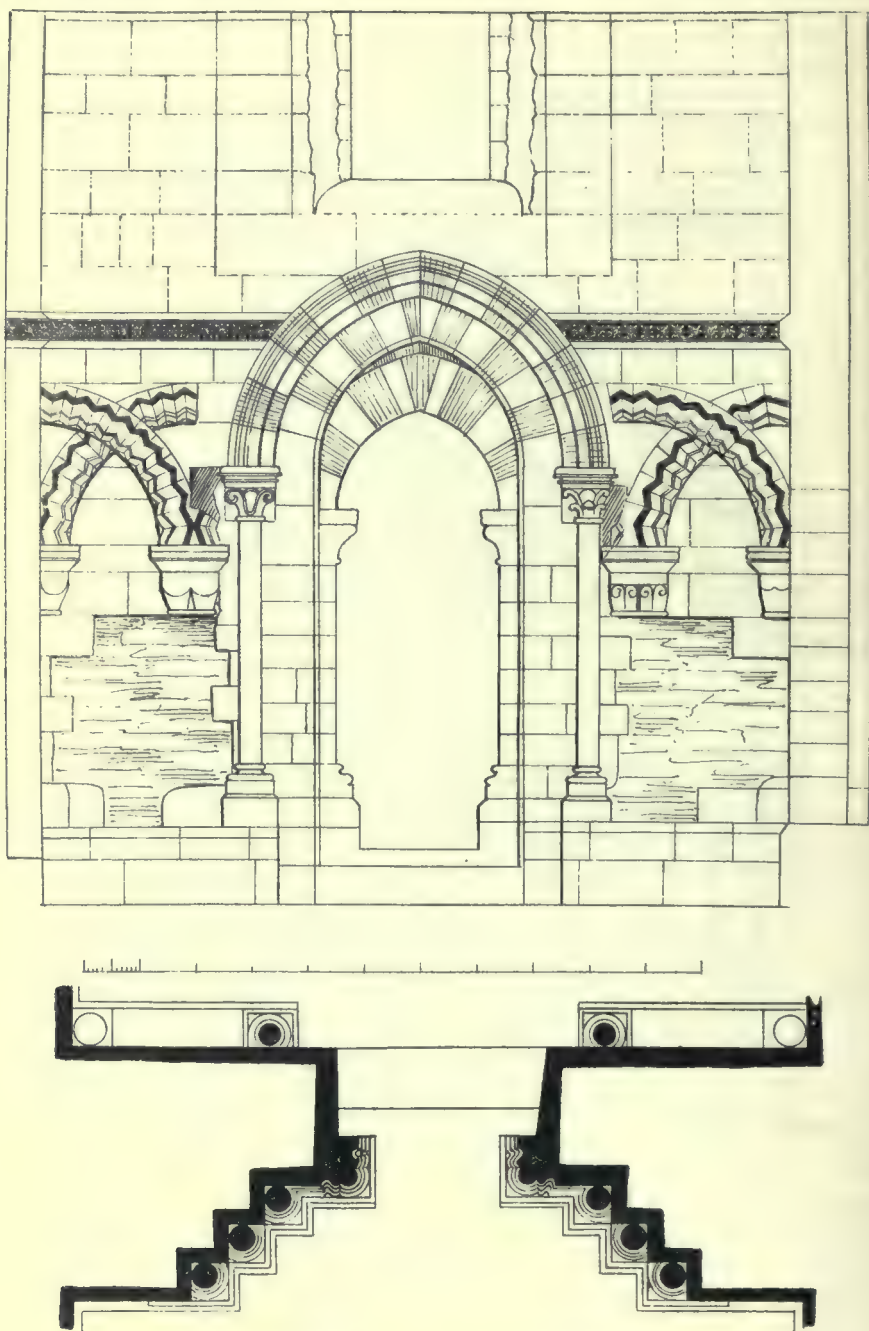
FIG. 232.—Kirkwall Cathedral. Interior of Doorway in South Transept. The shaded voussoirs are of yellow and the remainder of red freestone.

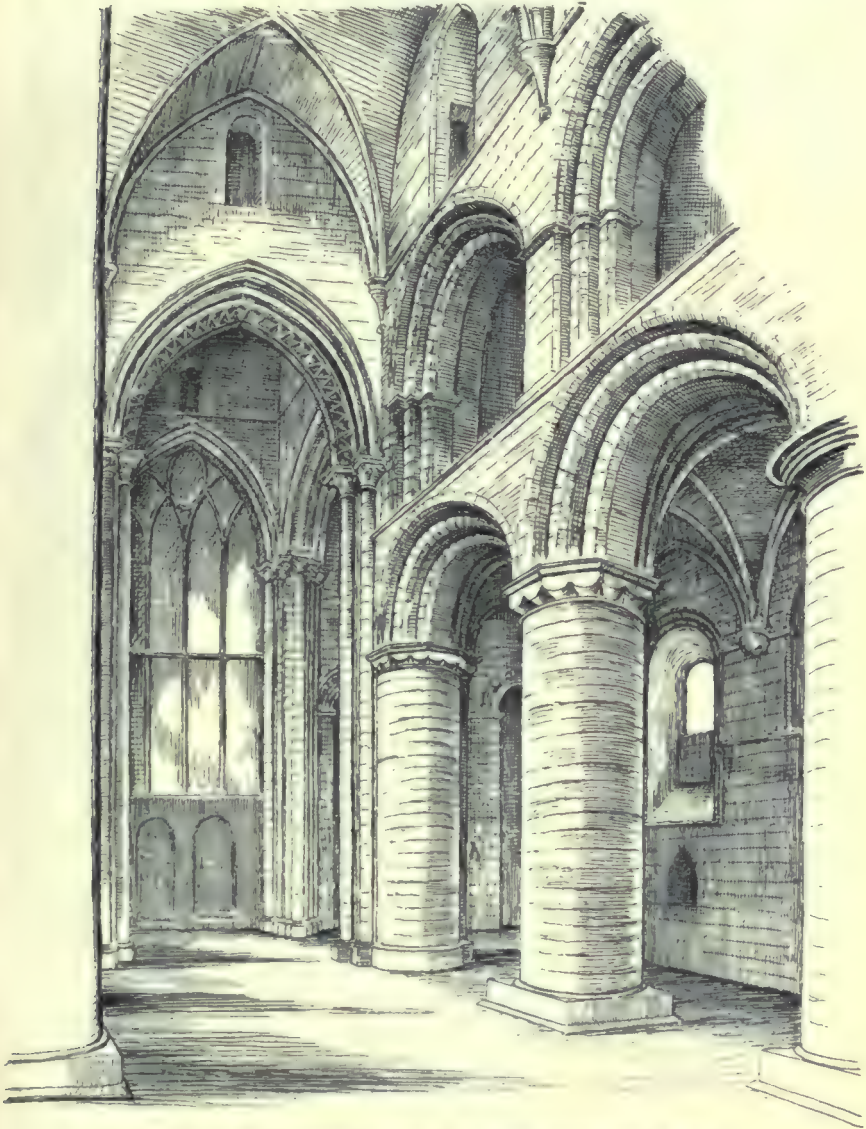
FIG. 233. — Kirkwall Cathedral. View of the Crossing from the Nave.

It seems likely that soon after the completion of the above portions attention was given to the continuation of the nave westwards for several bays. The piers have the same round form as the original ones, but the caps are no longer octagonal, but round (see Figs. 224 and 233), and instead of the cushion form, the caps are moulded. The north

After the Norman period above described, a distinct change of style is observable. This is prominently seen in the piers and arches of the crossing (see Figs. 233 and 235), which are of an advanced transition style, and appear to have been introduced in lieu of the old Norman piers. Possibly, however, the older piers are preserved and excased in the new. The latter (Fig. 239) are arranged in the form of clustered shafts, approaching first pointed in plan. The bases and caps of the shafts are of transition character, being very like those of Jedburgh Abbey, a good transition example. Some, however, have a tendency to foliage, but all are much damaged. The arches are in distinct orders, like first pointed work, and the inner order of those next the nave and choir is enriched with a large boldly relieved chevron ornament (see Fig. 233). The windows in the choir nearest the main arches of the crossing, and the triforium openings into the transept, appear to have been altered and rebuilt at the time of this operation. The upper part of the north transept was probably raised and its windows inserted at this time, as they are of transition character; but the raising of the south transept and introduction of the rose window in it is of a somewhat later date. This circular window (see Fig. 235) is very similar to that in the east window of the choir. The chapels on the east side of the transept are also of the transition period. Both internally, including the vaulting, and externally, including the pointed windows (see Figs. 229 and 230), the work of these chapels is very advanced transition in style. Of course, it must be understood that the style is referred to, not the date. The transition style may not have penetrated to Orkney till a long time after it had been abandoned further south, possibly not till the middle of the thirteenth

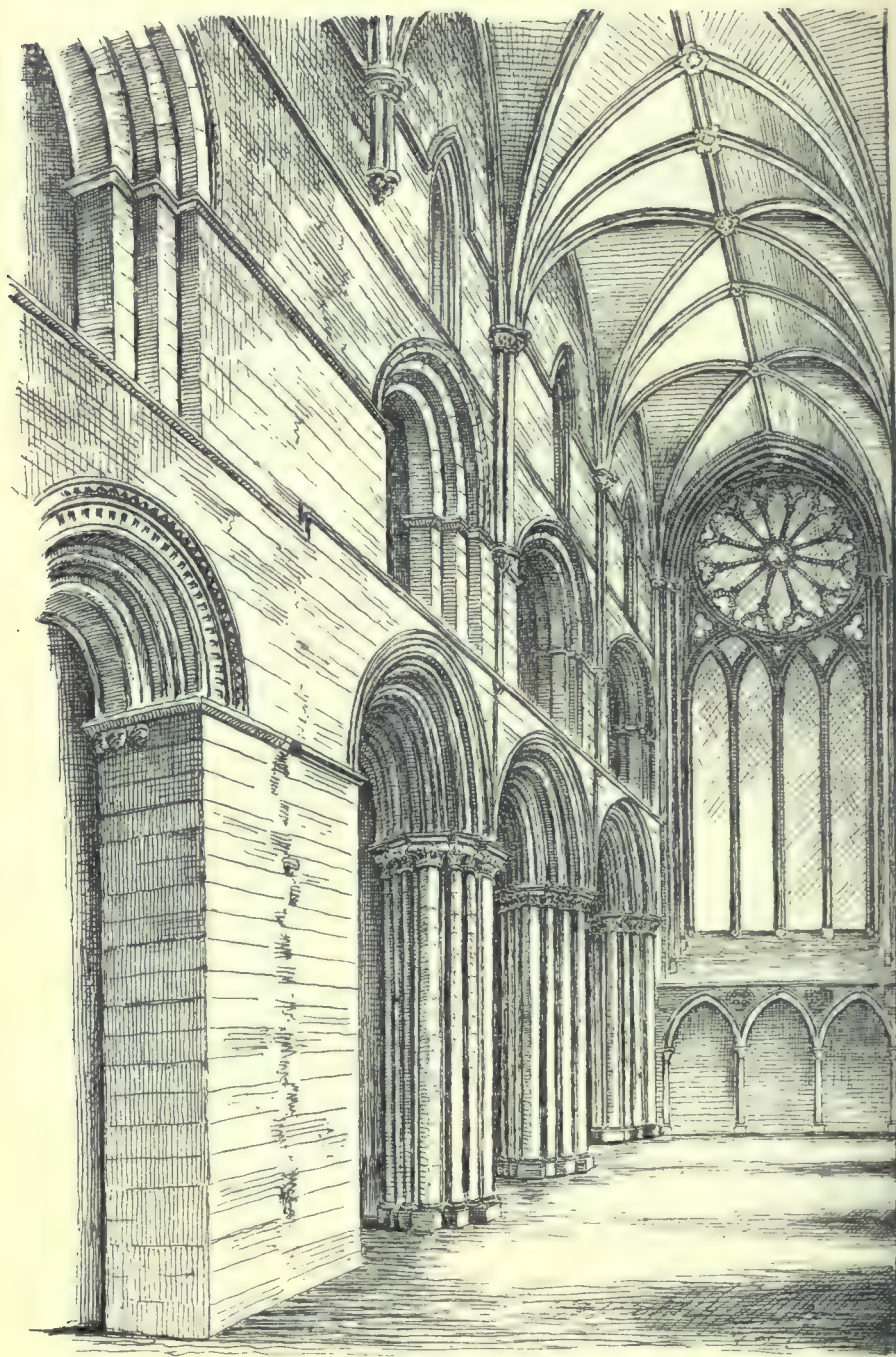
FIG. 234.—Kirkwall Cathedral. Choir, looking East.

The east end of the cathedral is of this period. The great east window (see Fig. 234) fills the whole space available. This window, including its mouldings, measures (according to Sir H. Dryden) 37 feet  $2\frac{1}{2}$  inches by 16 feet  $7\frac{1}{2}$  inches. It is well designed, and has side shafts of first pointed form, while the tracery is perhaps a little more advanced. The great rose in the arch, which expands over the whole of the mullions and arches of the tracery, is (as pointed out by Sir H. Dryden) quite peculiar and unique. The three-arched recesses under the east window indicate that the altar stood free from the wall. On the exterior, the junction of the new buttresses with the old Norman ones is distinctly seen. (See Fig. 230.) The former are of red freestone, and project with water tables in stages, while the latter are flat and shallow. The side windows have plain splays in the jambs, and have no caps, one round-headed window on the south side has two lights, and a doorway is formed beneath it. A large base course goes round the choir and marks the new work. It is also continued round the transept chapels at a lower level. Besides the raising of the clerestory walls, above referred to, the aisle walls of the choir have also been raised. On the north side (see Fig. 229) this is effected by leaving the old parapet and building a second parapet above it, while on the south side (see Fig. 230) the old parapet has been removed and the wall heightened with red ashlar, and a new parapet placed at the higher level. Several square windows have been cut in the lower part of the north choir wall. These are modern, and are not shown in the sketch. Their object is to admit light under a gallery which has been inserted in the north aisle. The floor of the choir has been raised, and is now reached by several steps from the transept; but the steps to the sanctuary are believed to have been where shown on the plan. As already mentioned, the clerestory and vaulting of the six eastmost bays of the nave was probably executed soon after the choir was finished, the outer wall of the clerestory being built with the same whitish stone as the heightened part of the choir. The windows are small and of plain-pointed form, like those of the choir. Some of them have the appearance of having been cut up into the vaulting, as if they had been inserted or heightened after the vaulting was built. It is to be remarked that while the parapets of the nave and choir are on the same level on the exterior, the vaulting of the nave is several feet lower than that of the choir.

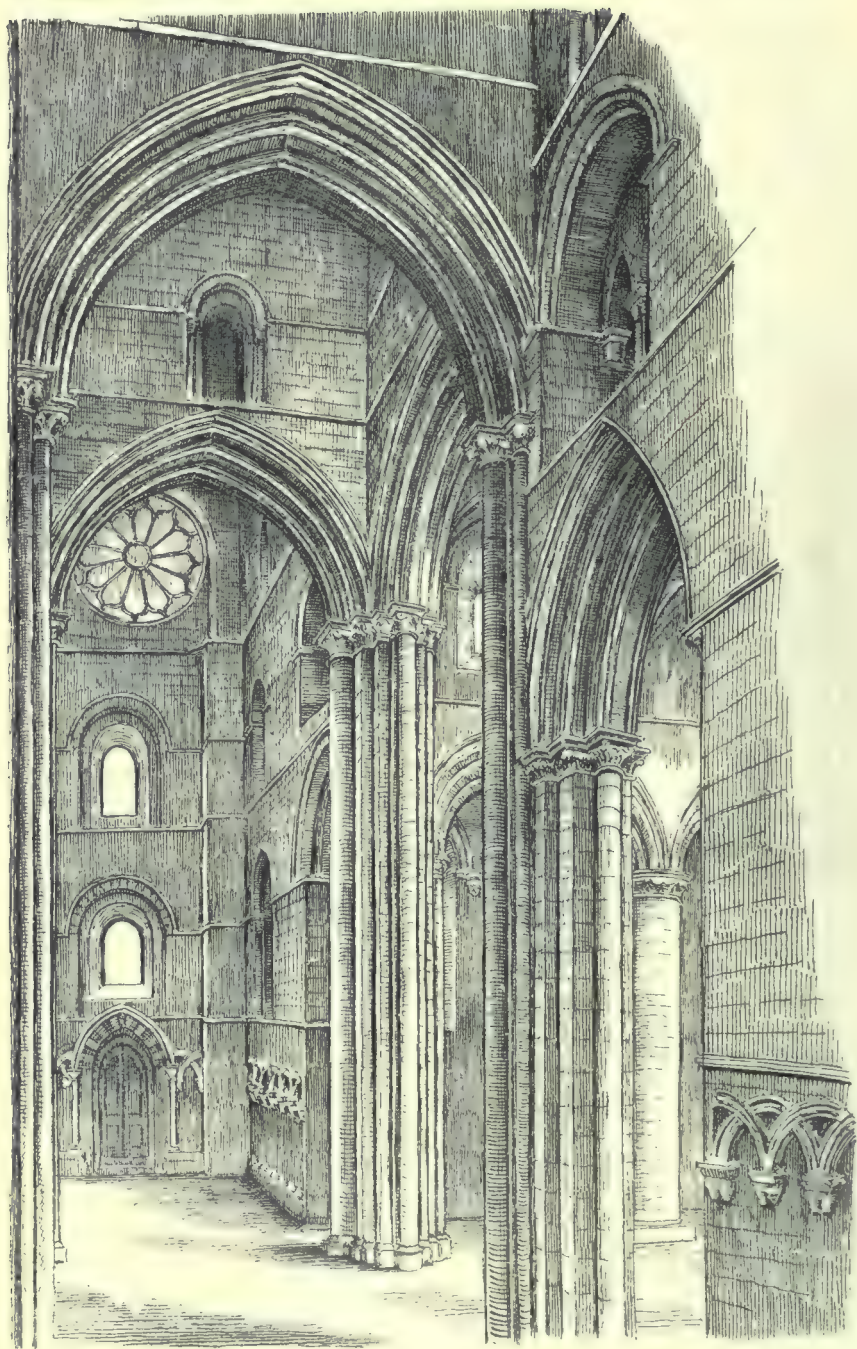
FIG. 285.—Kirkwall Cathedral. The Crossing and South Transept.

the transept. (See Fig. 235). The large arches leading into the east chapels were formed originally, but the chapels were built later. The lower string course of the transept is enriched with a four-leaved flower. (See Fig. 232.)

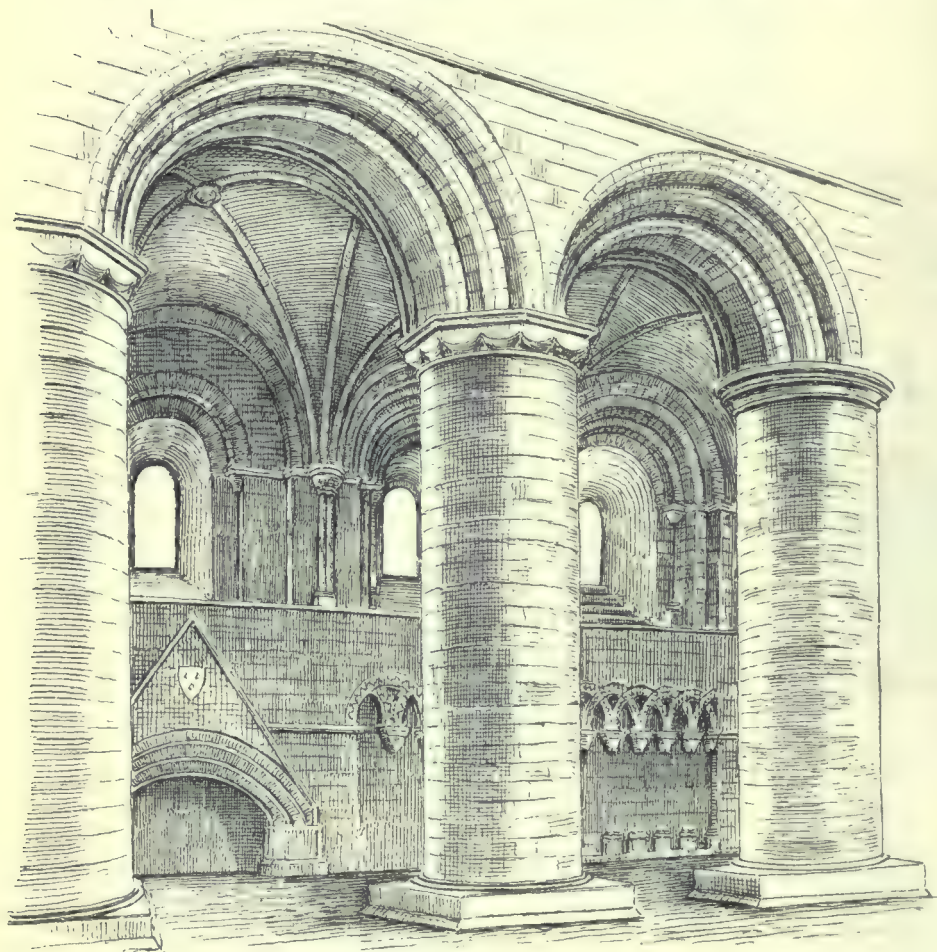
FIG. 237.—Kirkwall Cathedral. South Aisle of Nave.

An arched recess, with a gablet over it, in the south nave aisle (see Fig. 237) is now empty, but is supposed, by Sir H. Dryden, to have been erected for some member of the family of the Stratherns, Earls of Orkney.

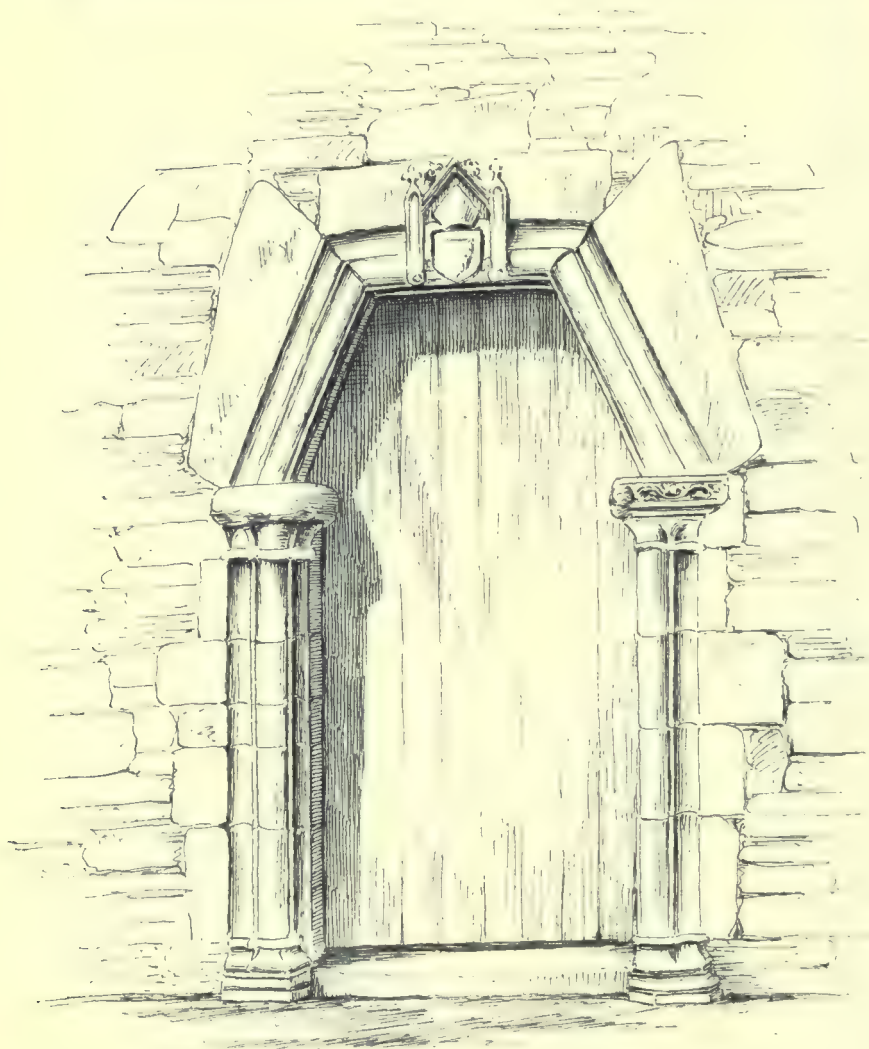
FIG. 238.—Kirkwall Cathedral. South Doorway of Nave.

In the south side of the nave a new exterior doorway (see Fig. 238) has been substituted for the old Nōrman doorway, the shafts and arch of the latter remaining in the interior. The new doorway is said to have been inserted by Bishop Reid in the sixteenth century. This is the same Bishop whom we meet with as Prior of Beaulieu and Abbot of Kinloss (*q.v.*)

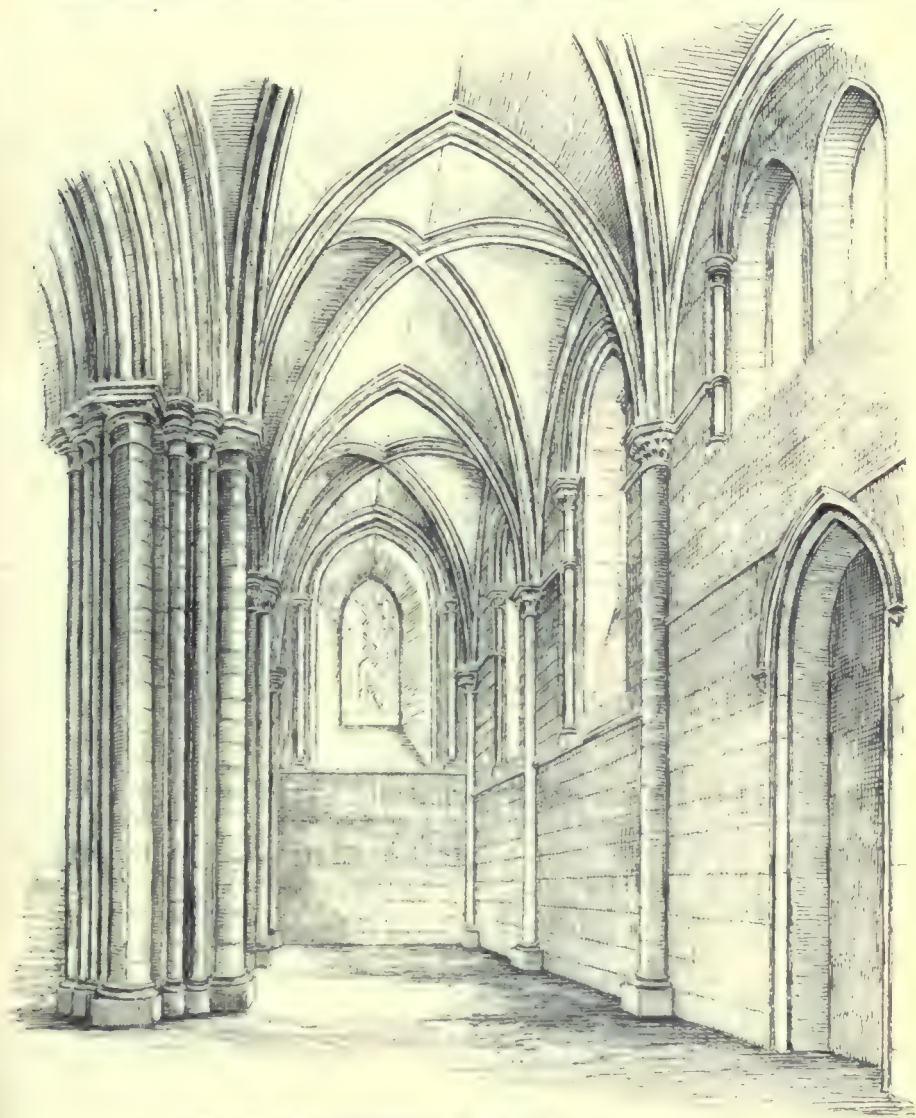
FIG. 240.—Kirkwall Cathedral. East End of South Aisle of Choir.

the extended choir aisles corresponds with that of the choir, and is very beautiful, though somewhat foreign in character. (See Fig. 240.) The ribs of the choir and aisle vaults have all bold sections of first pointed form.

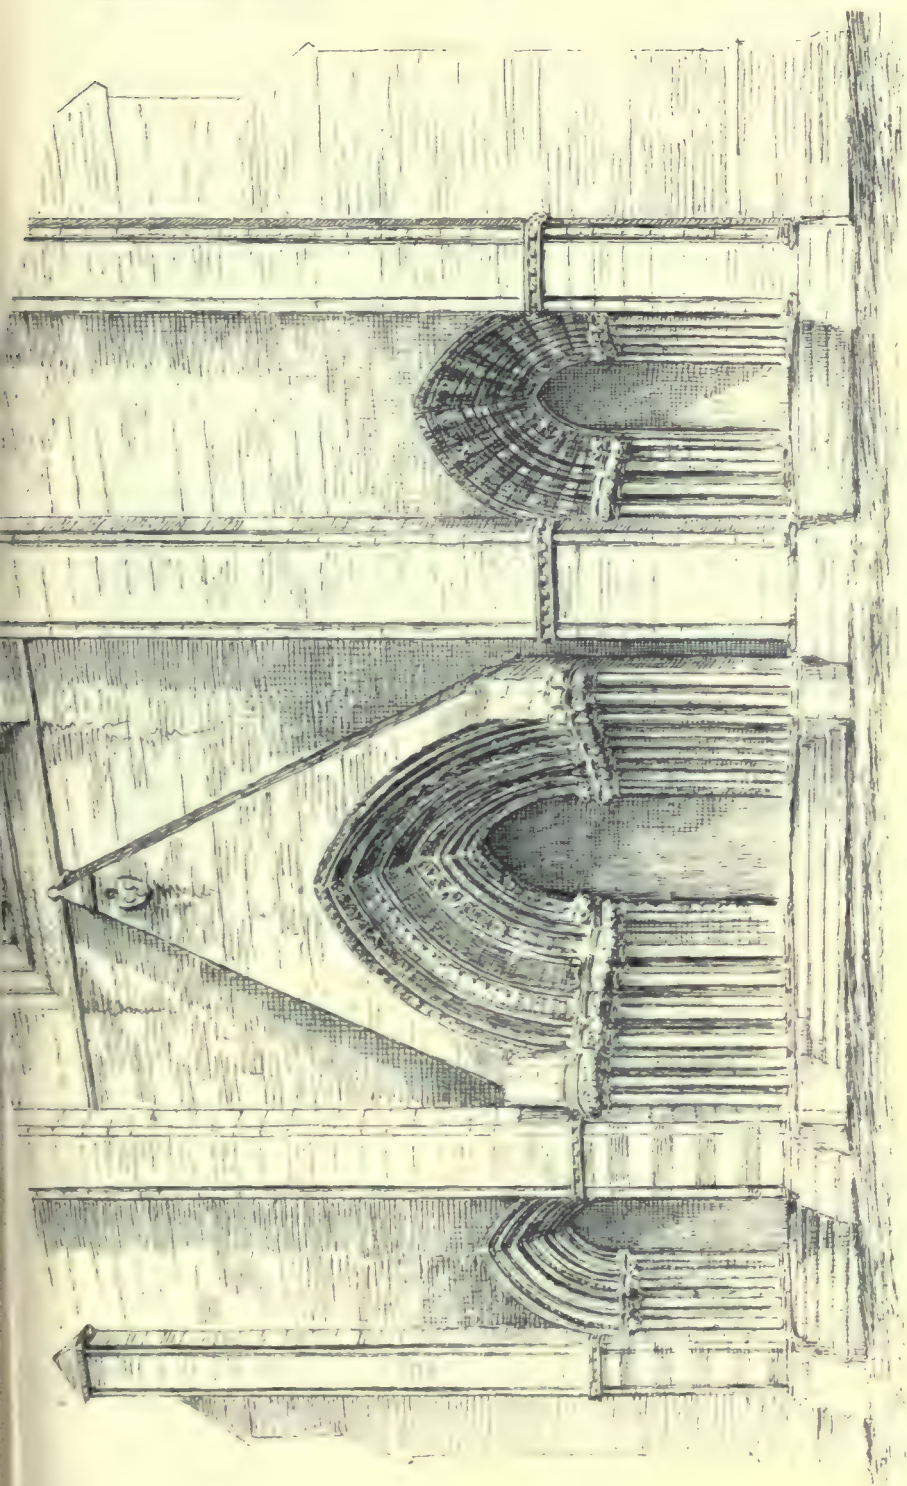
FIG. 241.—Kirkwall Cathedral. West Doorways.

The buttresses between the west doorways are, so far as original, also carried up in alternate red and yellow courses. (See Fig. 241.) The upper part of the gablet over the centre doorway is of the seventeenth century, and bears the shield of Sir George Hay of Kinfauns, who rented the lands of the bishopric in the beginning of the seventeenth century. A crozier is added to the shield in connection with the lands of the see. (See enlarged sketch in Fig. 244.)

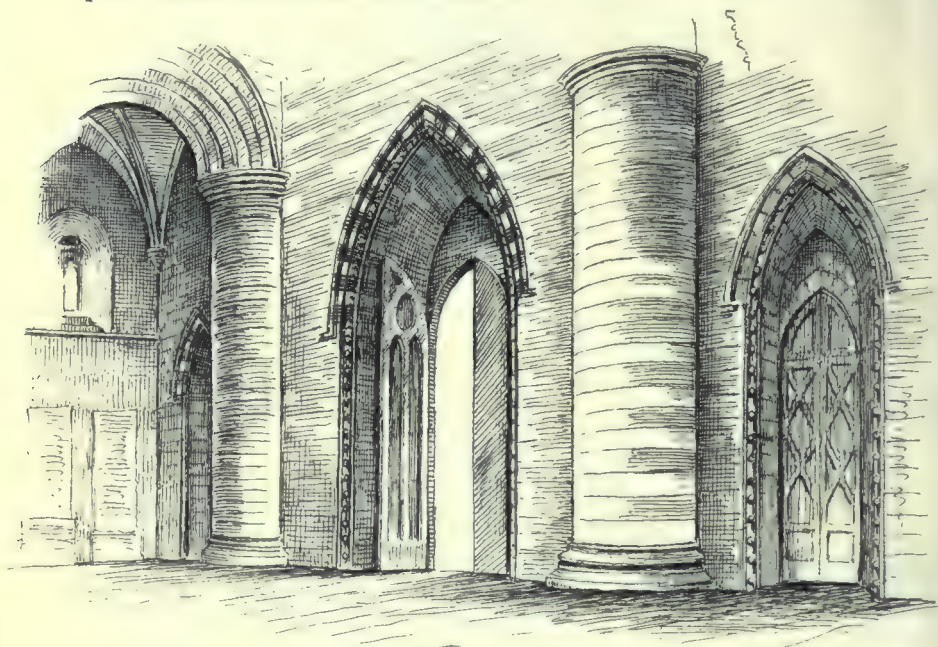
FIG. 242.—Kirkwall Cathedral. Interior of West Doorways.

In the interior the west doorways and responds of piers (Fig. 242) are constructed with alternate bands of red and yellow stone, and the scansion moulding is enriched with a ball ornament. The scansion of the doorway of the north nave aisle has a similar enrichment, showing that it must have been restored at a late date, as already mentioned.

The upper part of the west front is of late construction, having probably been carried out when the two west bays of the nave were built. These bays, as above mentioned, were added to the cathedral at a late period, and are almost entirely built with red freestone. The piers are designed in imitation of the old nave piers, but the caps and bases have different mouldings, and the plinth of the base is round, while that of the older bases is square. (See Fig. 242.)

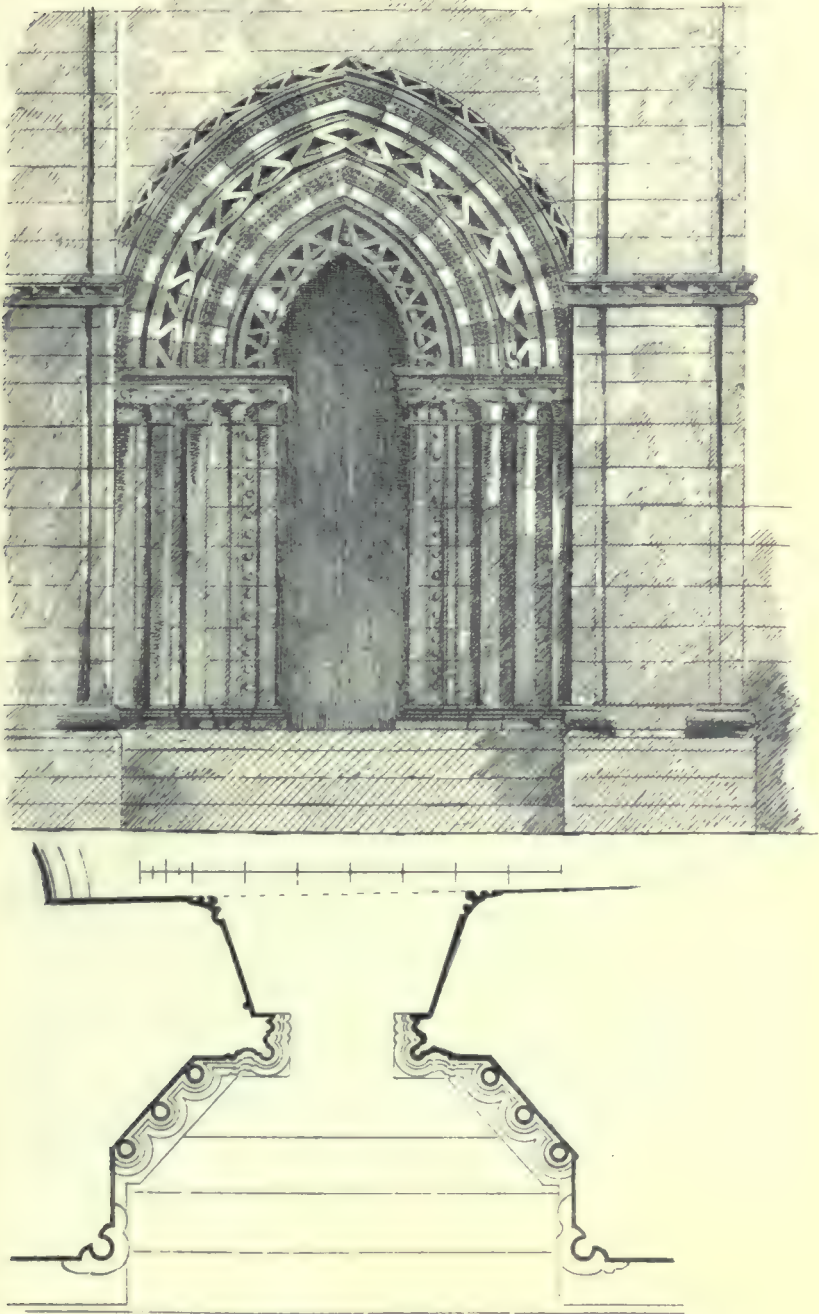
FIG. 243.—Kirkwall Cathedral. Plan and Elevation of South Doorway of West End.

The shafts have all been detached, as shown in the plans. They have been renewed ; but, as Sir H. Dryden suggests, no doubt correctly, they were probably at first in red and yellow stone alternately.

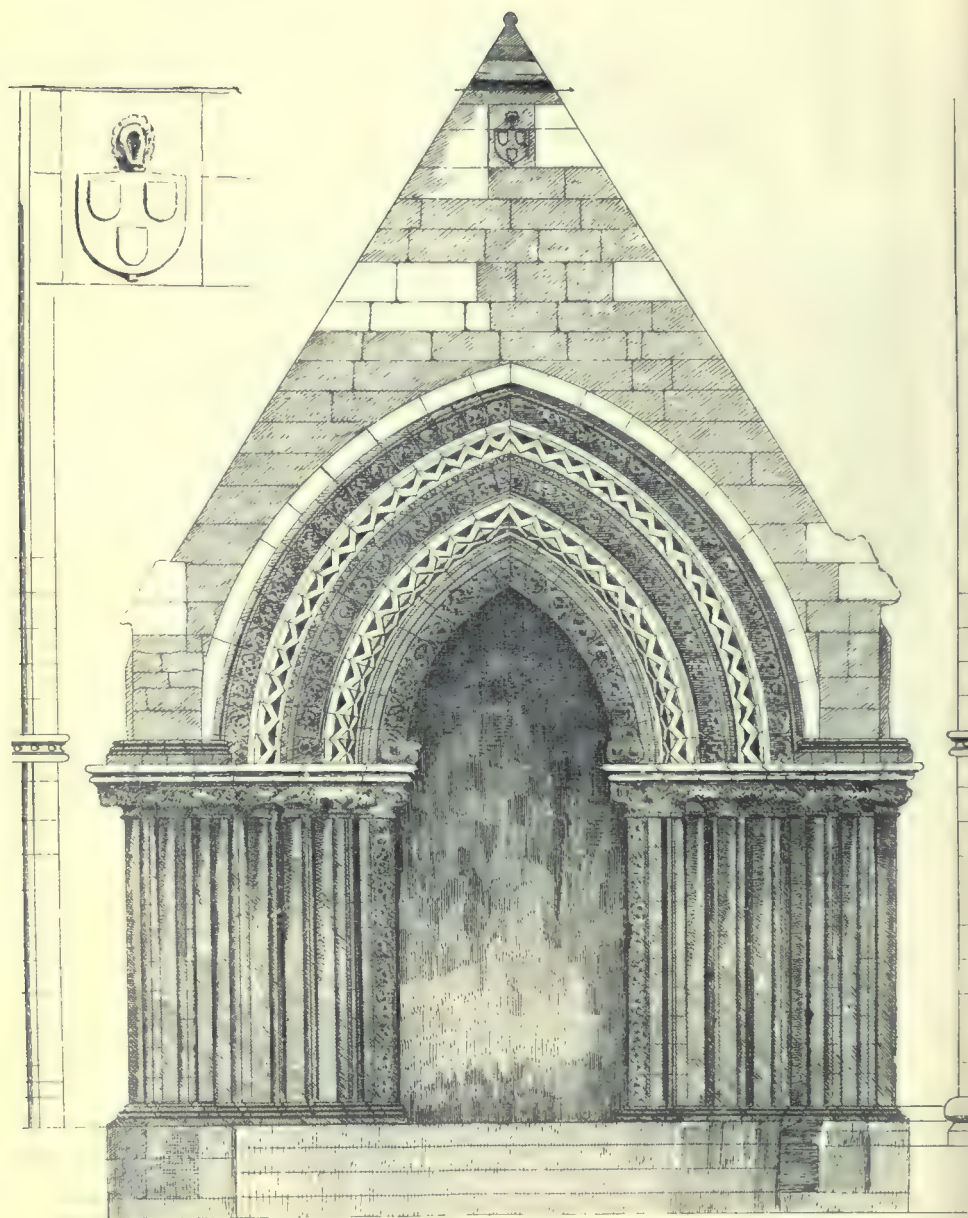
FIG. 244.—Kirkwall Cathedral. Elevation at Central Doorway of West End.

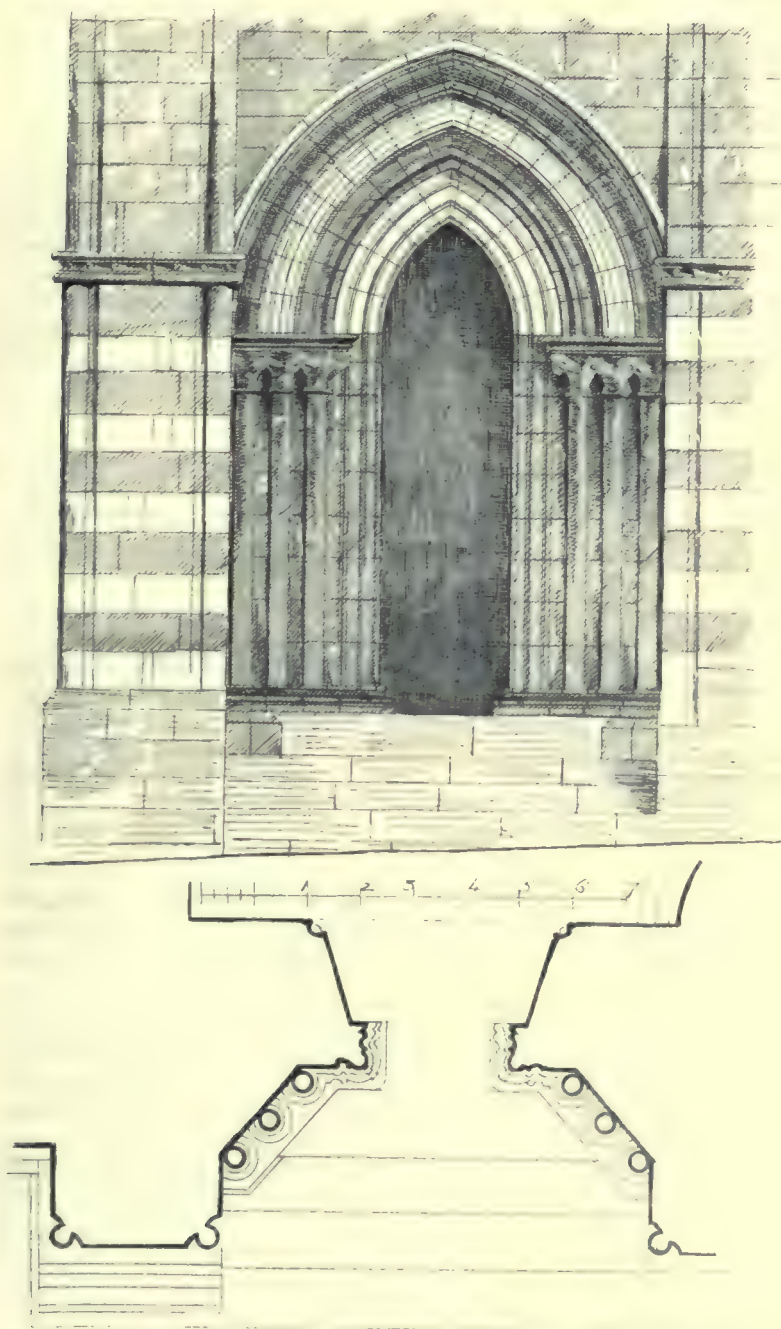
FIG. 245.—Kirkwall Cathedral. Plan and Elevation of North Doorway of West End.

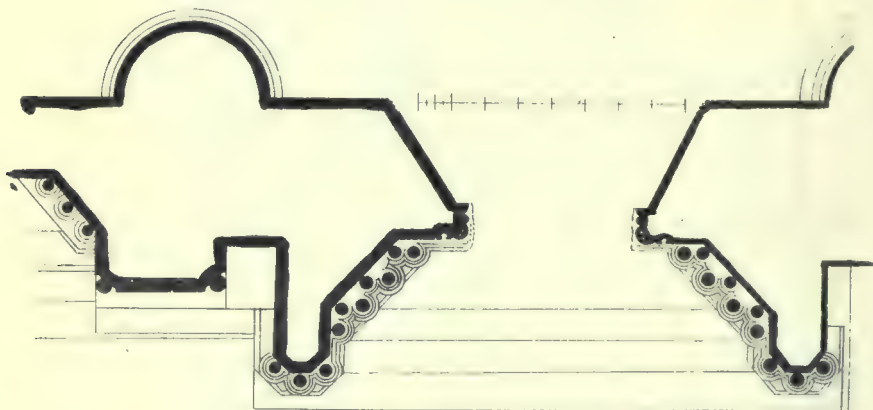
FIG. 246.—Kirkwall Cathedral. Plan of Central Doorway of West End.

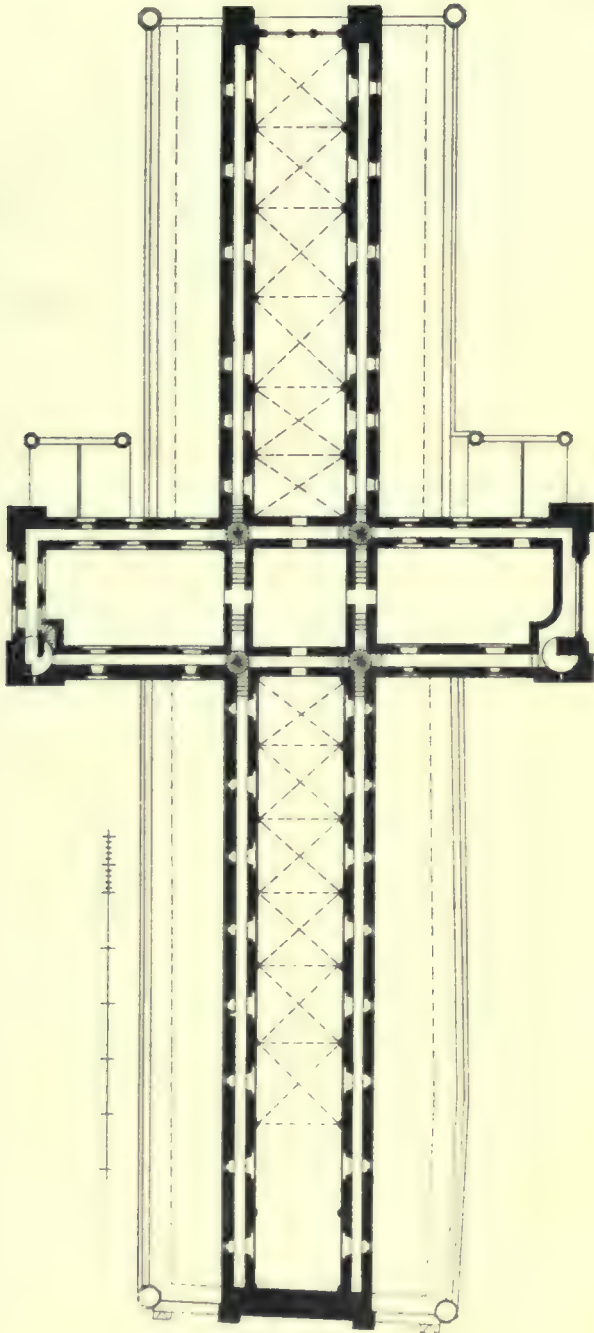
FIG. 247.—Kirkwall Cathedral. Plan at Level of Clerestory.

An unusually wide wheel stair leads from the north-west and south-west angles of the transept to the upper parts of the edifice. These stairs are connected with passages which circulate all round the clerestory and triforium in the thickness of the walls (Fig. 247), and give access to every part of the building. They also pass round the tower at each story, and are connected with small wheel stairs in the angles, by one of which access is obtained to the roof.
